# RESEARCH MEMORANDUM

FURTHER INVESTIGATION OF A GAS TURBINE WITH NATIONAL BUREAU  
OF STANDARDS BODY 4811C CERAMIC ROTOR BLADES

By John C. Freche

NACA RM E9107

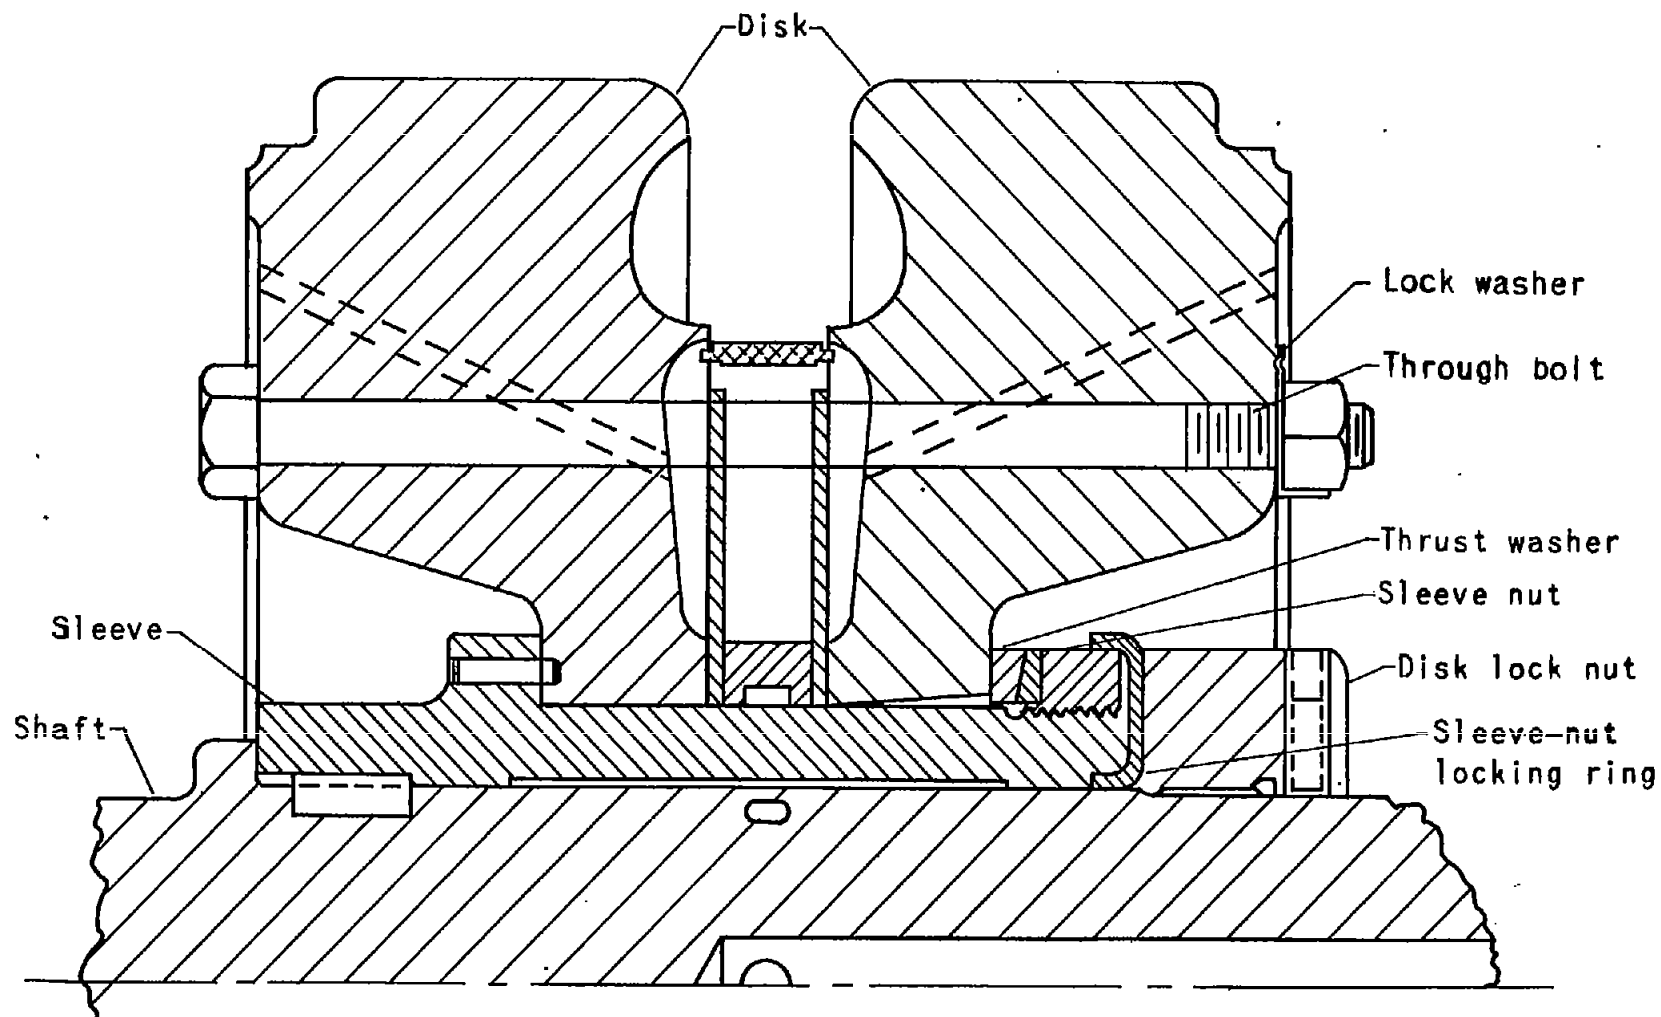
Figure 1. - Assembly of disk, shaft, and sleeve.

Turbine disks. - Minor mechanical changes were made in the experimental apparatus to provide a better method of fastening the disks together and to the shaft. These changes resulted in a simplified method of assembly and added to the mechanical stability of the rig. The disk bore was increased and a sleeve was provided upon which the disks were placed and so pinned that no relative motion between sleeve and disks could occur (fig. 1). This disk-and-sleeve assembly was slipped over the shaft and held in place by another nut that locked the sleeve to the shaft. The intermediary sleeve was placed between the disks and the shaft to absorb possible bending loads imposed on the shaft from a slight misalignment of the heavy disks. Four through bolts were installed at a radius slightly less than the inner radius of the blade-ring assembly as an additional means of uniformly clamping the disks together (fig. 1).

In assembling the disks and the blade ring, an axial load was applied to the disks by a hydraulic press while the lock nut was tightened on the sleeve and the distance across the disks at the outermost radius was measured at 90° intervals where the through bolts were located. These bolts were tightened as required to maintain a constant measured distance across the disks around the entire disk circumference until the center lock nut was completely drawn up. The bolts were then locked to the disks.

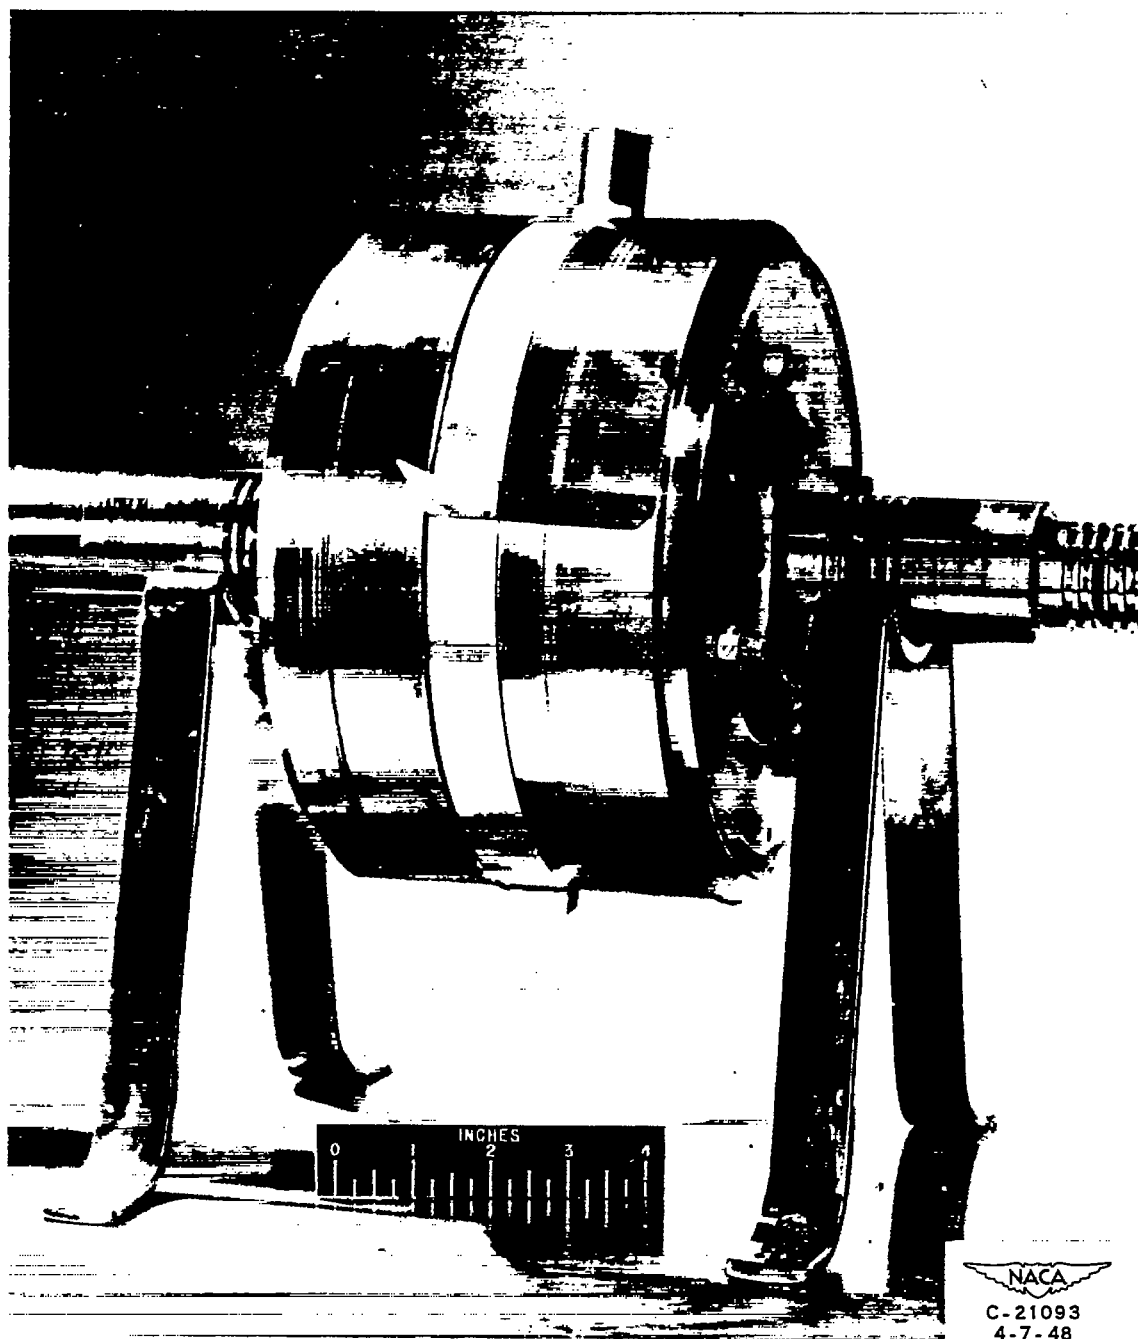
Figure 2. - Turbine wheel assembled with four Body 4811C blades and four metal spacers for rotating heat-shock runs.

Blade assembly. - The method of assembling the blade ring for the endurance runs was the same as that in reference 2. For the rotating heat-shock cycles, however, the assembly consisted of four blades and four metal spacers. This blade ring did not require use of the assembly fixture described in reference 1. A strip of 0.025-inch asbestos cloth was fastened with a quick-drying cement around the base of the blades to reduce the possibility of damage from motion of the blades relative to the metal spacers. A 0.032-inch asbestos-cloth cushion was fastened around the sides and shoulders of the blade bases in contact with the disk-clamping surfaces. The four blades were then separated by four metal spacers contoured to match the rotor-clamping surfaces and clamped between the two disks. The rotor assembled with four blades and four metal spacers is shown in figure 2.

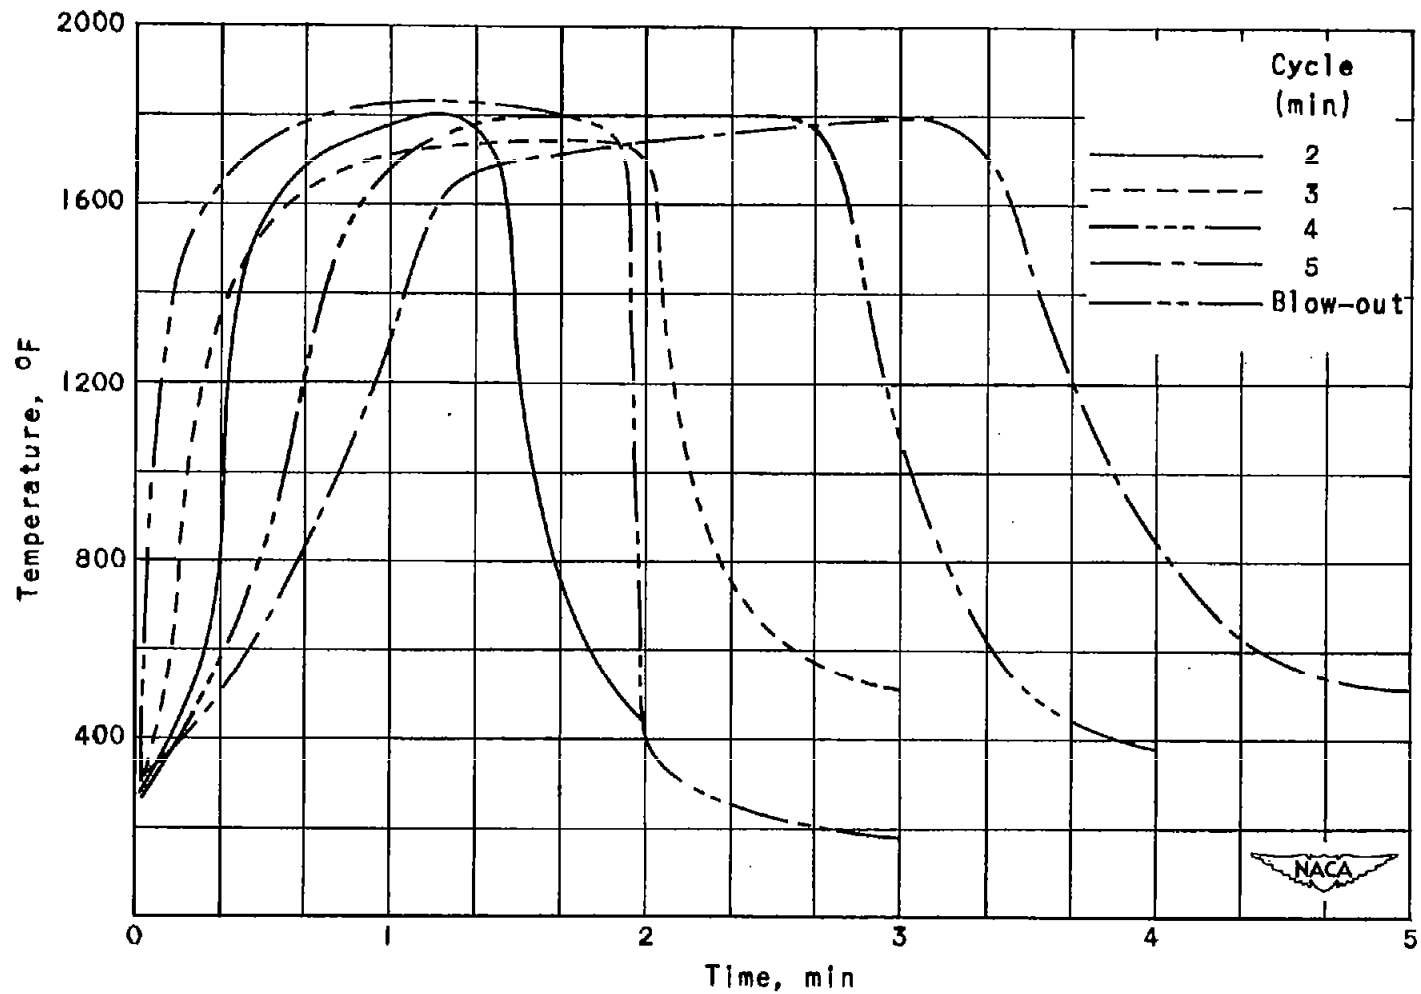
Figure 3. - Rotating heat-shock cycles with blade assembly 3. Blade centrifugal load, three-fourths of design value; turbine tip speed, 842 feet per second (16,000 rpm).

The temperature variation with time for one complete series of heat-shock cycles is presented in figure 3. The gas temperature was varied by manual adjustments of the valve controlling the fuel supply to the burner. A constant rate of temperature increase or decrease was not always maintained, which explains the absence of parallelism in some of the curves.

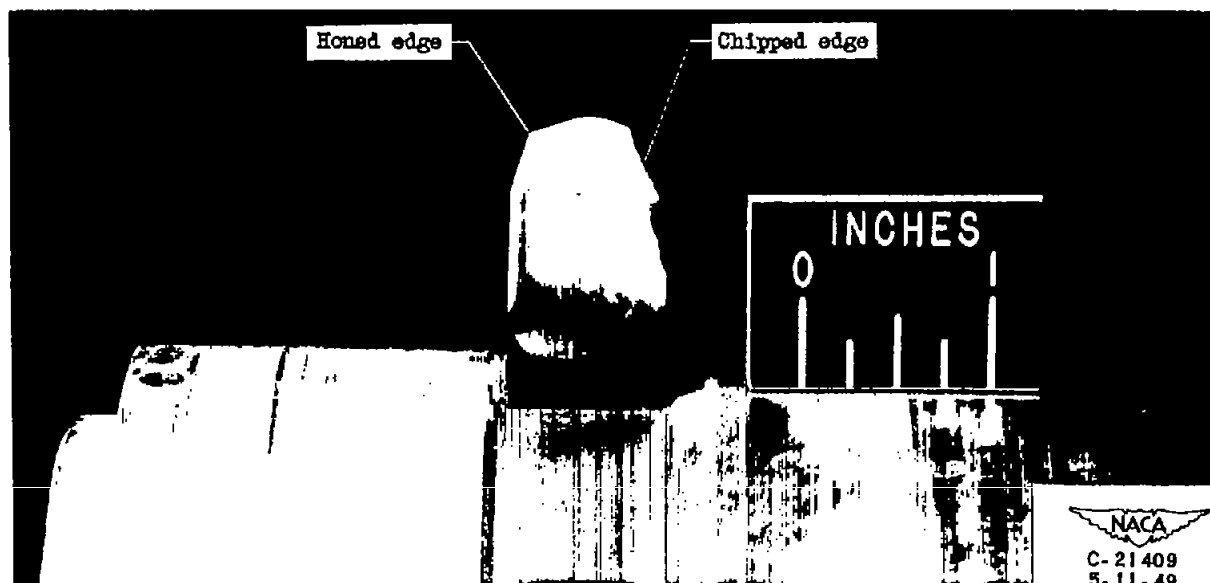
Figure 4. - Close-up of turbine blade showing leading edge chipped during rotating heat-shock runs with blade assembly 1.

Rotating heat-shock runs. - Blade assembly 1 was subjected to a series of heat-shock cycles at tip speeds up to 737 feet per second. The minimum-shock cycle was a change in gas temperature from  $300^{\circ}$  to  $1200^{\circ}$  to  $300^{\circ}$  F in 5 minutes. The rate of inlet-gas temperature increase was equal to approximately  $9^{\circ}$  F per second and the rate of inlet-gas temperature decrease was equal to approximately  $9^{\circ}$  F per second. The maximum-shock cycle was a change in inlet-gas temperature from  $300^{\circ}$  to  $1800^{\circ}$  to  $300^{\circ}$  F in 2 minutes. The rate of inlet-gas temperature increase was equal to approximately  $37\frac{1}{2}^{\circ}$  F per second and the rate of inlet-gas temperature decrease was equivalent to approximately  $37\frac{1}{2}^{\circ}$  F per second. The blades successfully withstood the complete series of heat-shock cycles except for a small part of the leading edge of one blade. Inspection of the turbine after the first series of cycles at a turbine tip speed of 263 feet per second revealed that a small part of the leading edge of one blade had chipped off. A close-up of this blade still assembled in the turbine wheel after the entire series of runs had been completed is shown in figure 4. All four blades used in this series of heat-shock cycles had already been chipped during previous endurance runs, but the rough edges had been honed prior to assembly in the turbine. It is possible that the chip lost during the heat-shock tests was the result of a previously undetected crack. Because no other breakage occurred Body 4811C blades evidently have a greater heat-shock resistance under load than was indicated by operation in reference 2.

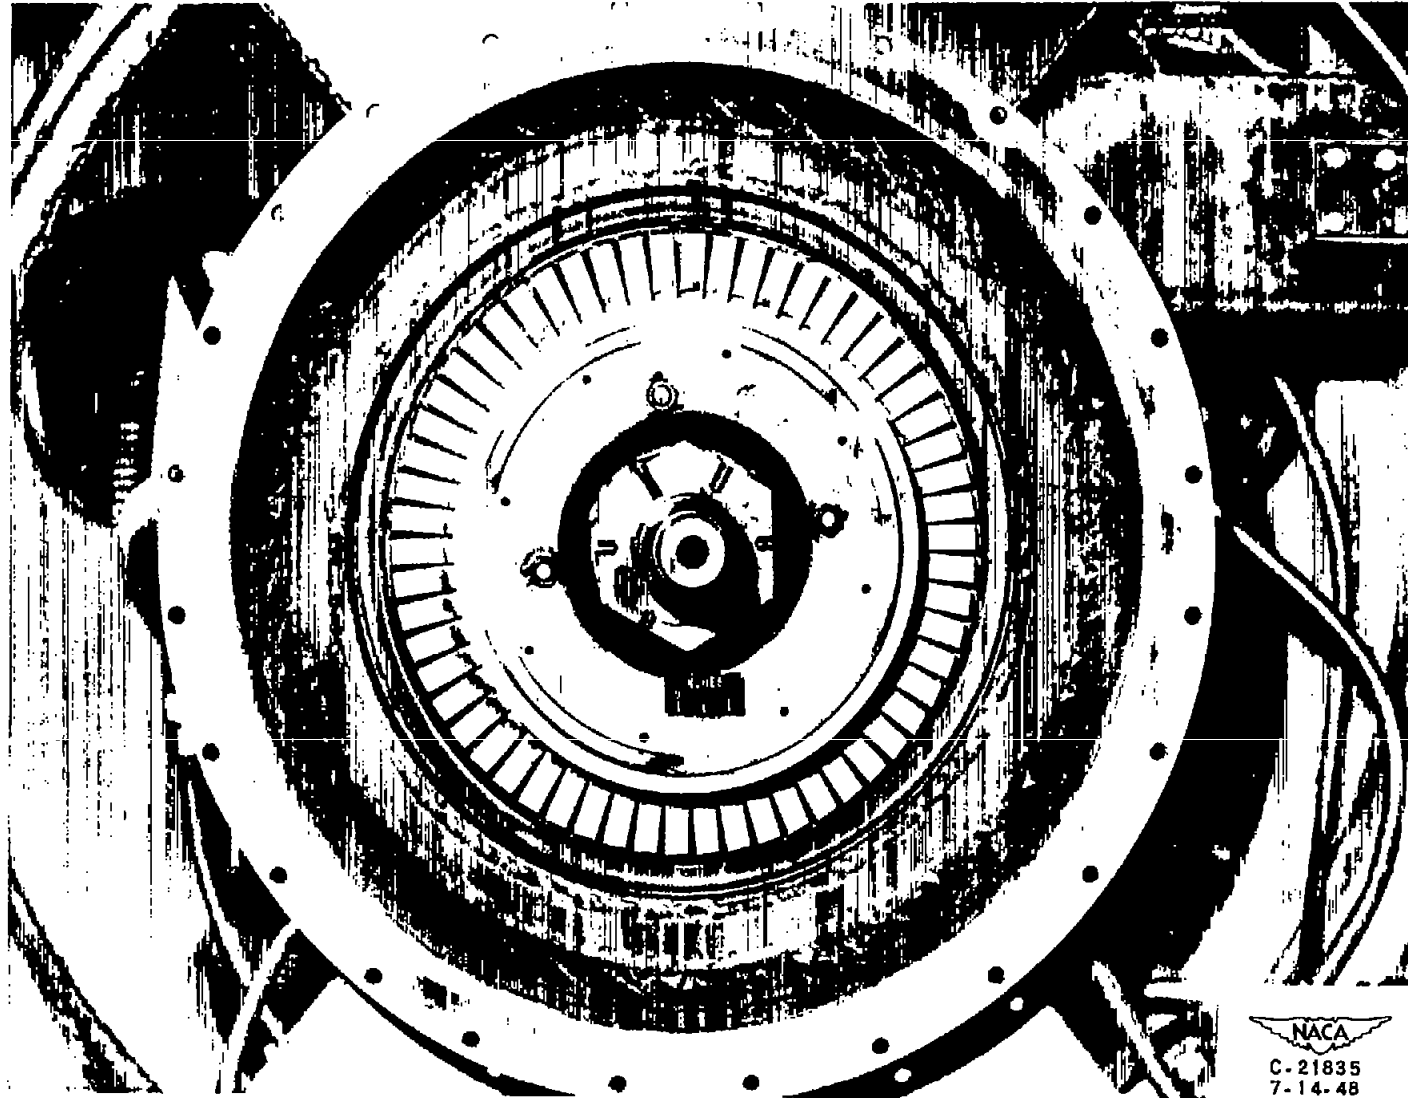
Figure 5. - Turbine rotor with Body 4611C blades in rig supporting structure after operation at turbine tip speed of 842 feet per second (16,000 rpm) and inlet-gas temperature of 1800° F.

Blade assembly 4 consisting of 58 new Body 4811C blades was operated for 60-minute intervals at  $1800^{\circ}$  F and various tip speeds up to 842 feet per second and at  $2000^{\circ}$  F at a tip speed of 631 feet per second without any damage to the blades. The turbine rotor and blade assembly after this period of operation is shown in figure 5. These runs were essentially endurance tests to determine the limiting conditions attainable with Body 4811C blades. The minimum operating conditions set for this run were the same as the maximum operating

conditions attained in the earlier investigation (reference 2). When the turbine was disassembled for inspection, it was found that the metal disks had become distorted.
